SERVICE BULLETIN

APPLICABILITY: 2013 Legacy & Outback Models with 2.5L FB Engines

SUBJECT: Surface Treatment Change To Oil Control Piston Rings

NUMBER: 02-143-13R
DATE: 09/19/13
REVISED: 03/20/14

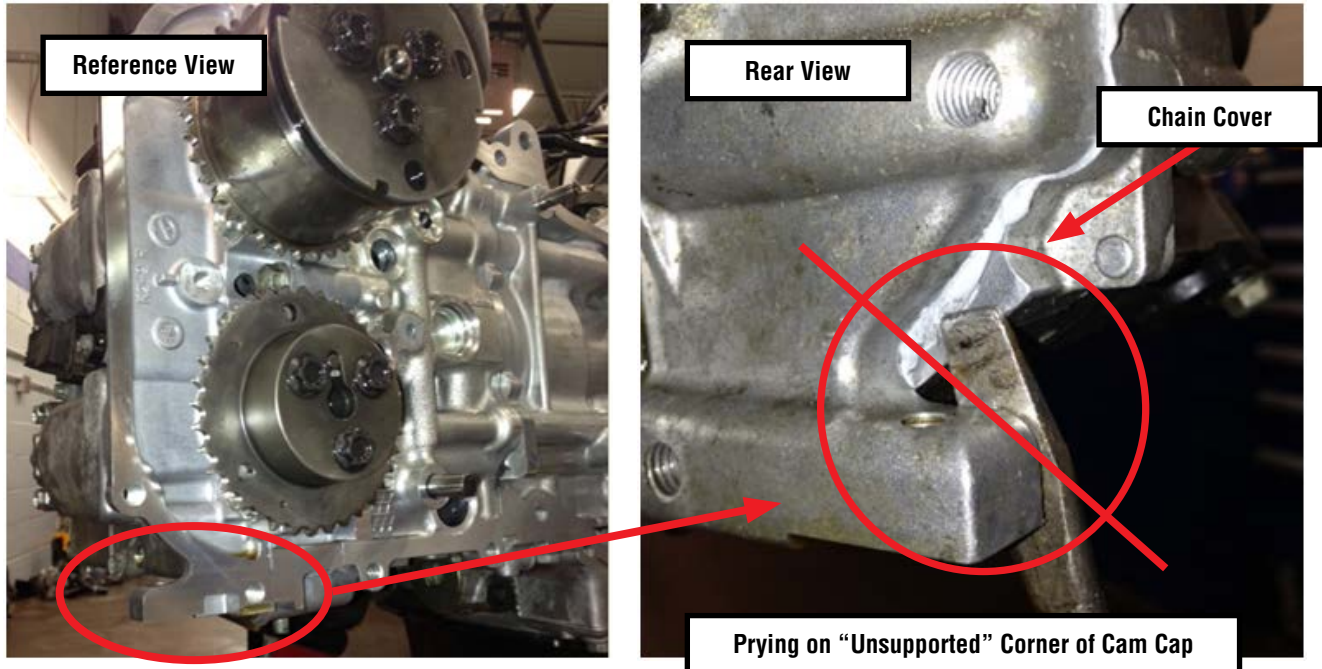
- **IMPORTANT:** After all 32 bolts securing the chain cover are removed, be **VERY** careful where you pry and what you pry on to break the silicone sealant bond. The photos below show an example of where NOT to pry. In this case, the cam cap became cracked requiring a complete cam carrier replacement. Patience is the key!

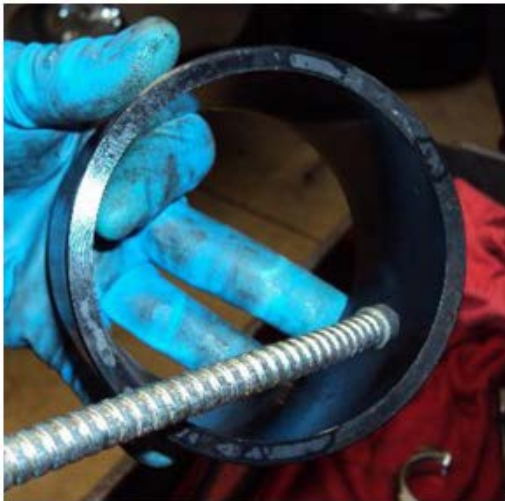
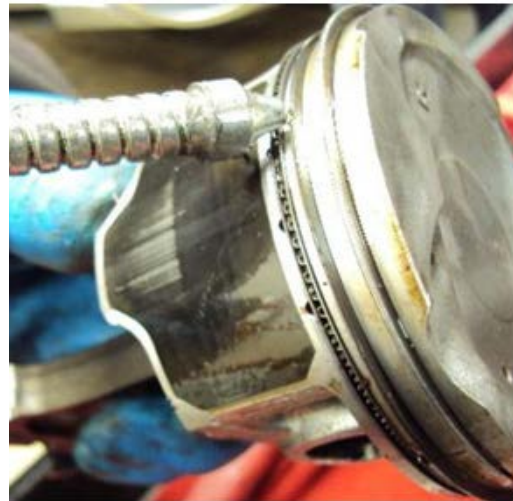
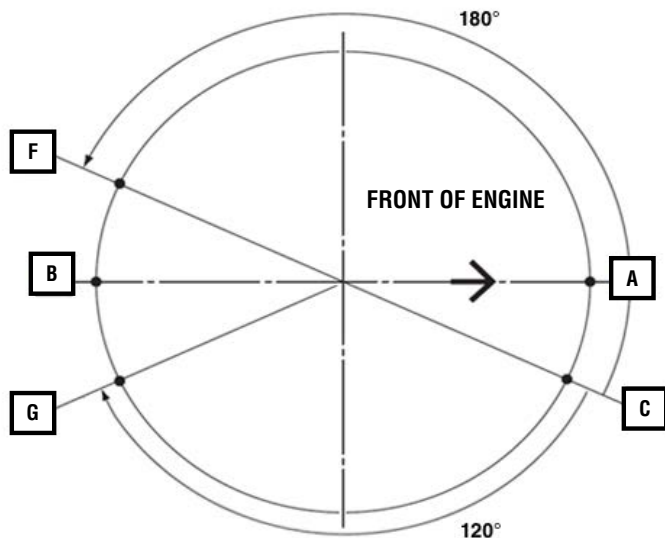
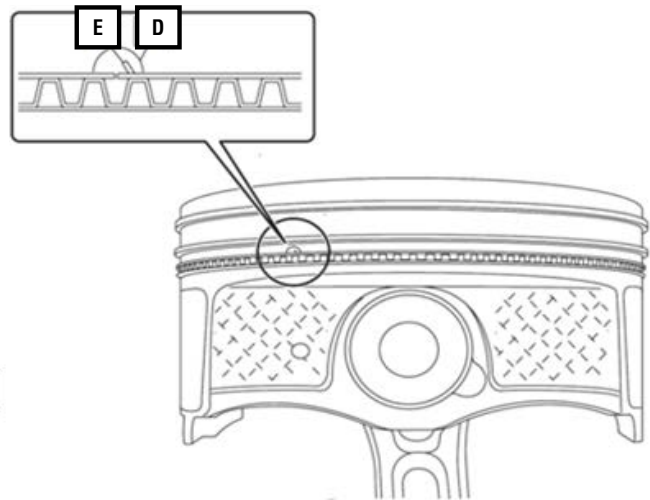
- “A”- Top compression ring end gap location
- “B”- Second compression ring end gap location (180 degrees away from “A”)
- “C”- Top oil control scraper ring end gap
- “D”- Recess in top of ring land to accept the “tang” of the upper oil control scraper ring - “E”
- “F”- Expander gap (180 degrees away from “C”)
- “G”- Bottom oil control scraper ring end gap (120 degrees away from “C”)

- When cleaning the pistons prior to installing the new rings, take care not to damage the anti-friction coating applied to the skirts. A mild parts cleaner may also be used with the Scotch-Brite Ultra-Fine #7448 (gray in color) to loosen and remove carbon deposits from the piston crown and from between the ring lands. Do not use Scotch-Brite to clean the piston skirts as it can damage the anti-friction coating. The ends of a removed compression ring may be used to carefully clean deposits from inside the ring lands. Rinse the piston / rod assemblies thoroughly and dry before installing the new rings onto the pistons. Refer to the Service Manual and the illustrations below for ring direction (marks facing upward) and end gap placements **before placing the piston/rod assembly into the ring compressor.**
