SERVICE BULLETIN

APPLICABILITY: 2013 Legacy & Outback Models with 2.5L FB Engines

SUBJECT: Surface Treatment Change To Oil Control Piston Rings

NUMBER: 02-143-13R
DATE: 09/19/13
REVISED: 03/20/14

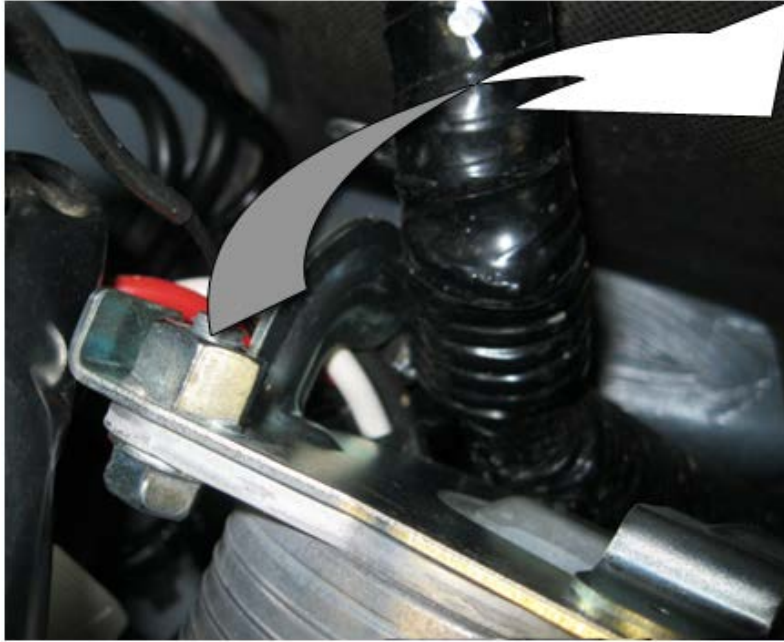
- When removing the CVT fluid cooler, leave it attached to the mounting bracket and remove it as an assembly (3 bolts) from the transmission. Disconnect just the engine coolant hoses from it and leave the 2 short CVT fluid lines alone. Hook one of the cooler's mounting bracket "ears" behind the bulkhead harness as shown in the photo below to keep the cooler assembly out of your way. Use a shop cloth between the "ear" and the bulkhead harness to prevent any chafing.

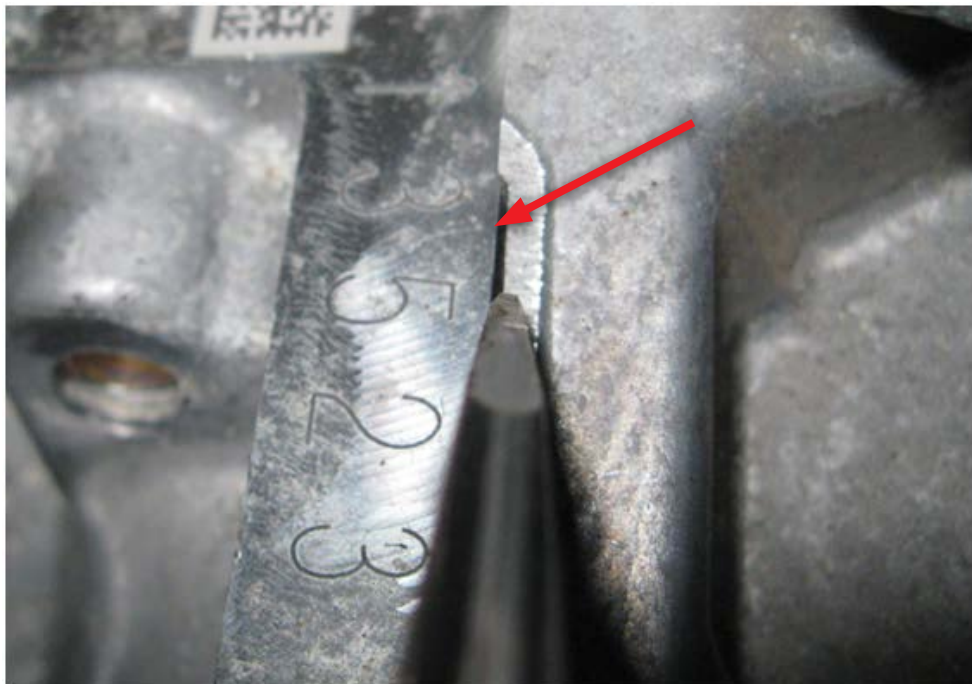
- To make separating the transmission (CVT) from the engine easier, there is a pry relief shown below in the machined mounting surface of the transmission case near the engine number. Use caution when applying any prying pressure and avoid twisting the tool to prevent case damage.

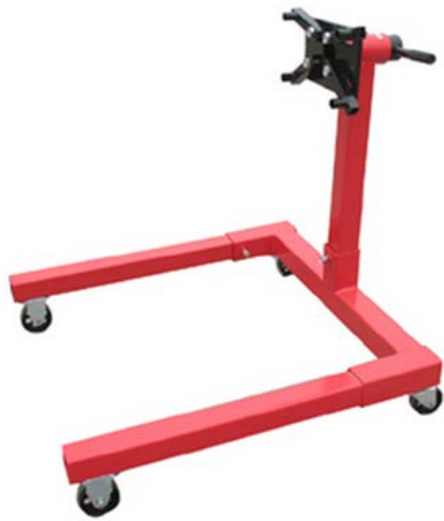
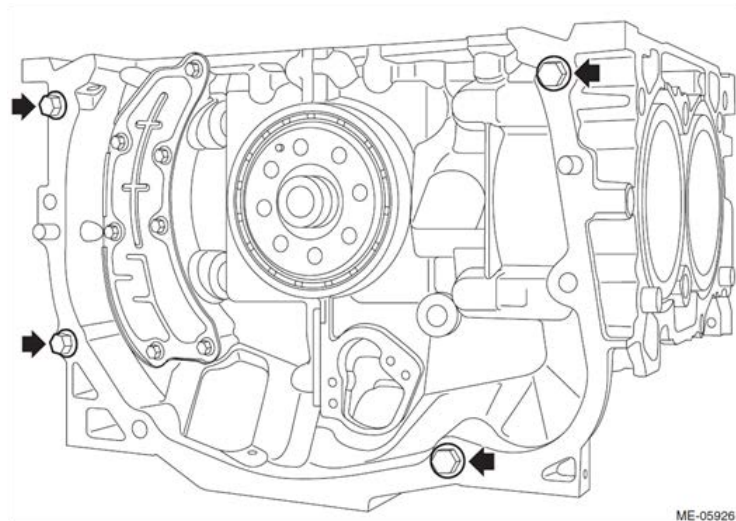
ME-05926

- Once the engine is removed, if you are using a generic engine stand (preferable since engine rotation is necessary), use the four mounting holes on the engine block shown below to mount it. Do not use the studs in the upper oil pan as the upper oil pan has to be removed to access the connecting rod bolts. **NOTE:** The connecting rod bolts are one-time-use and must be replaced.

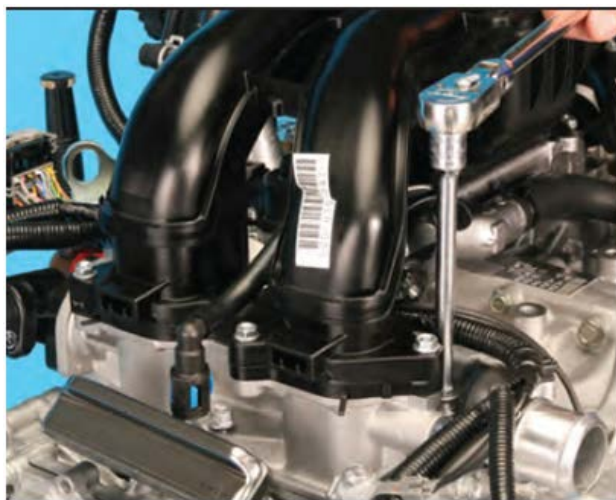
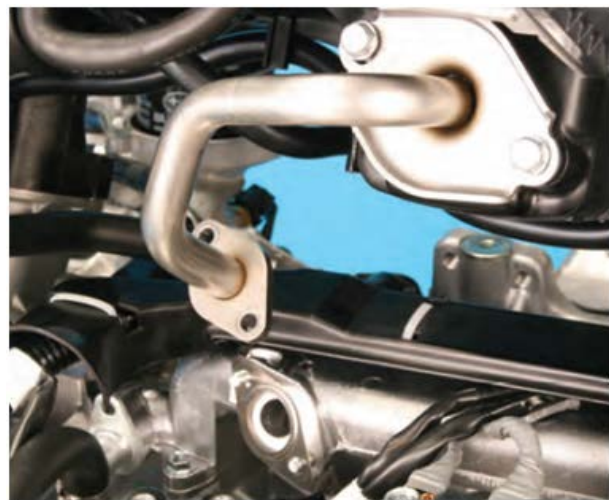
- When removing the intake manifold, as shown in the photos below, leave the TGV assemblies attached to the upper intake, remove the 2 nuts holding the EGR tube to the water pipe then remove the complete assembly from the cylinder heads as a unit.

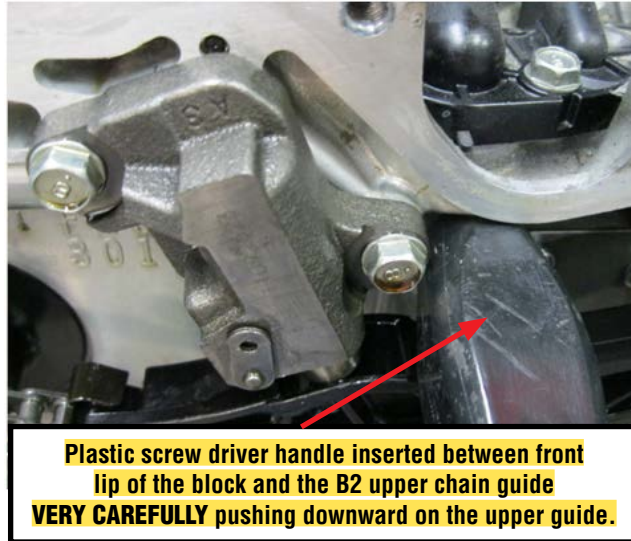
- If necessary, insert a plastic screwdriver handle between the lip of the block and the left side (B2) guide. Then, **VERY CAREFULLY** push down on the guide just enough to get the extra tensioner notch / “click”. When using this method, always make sure you are using plastic on plastic and NOT metal on plastic to avoid damaging the chain guides.

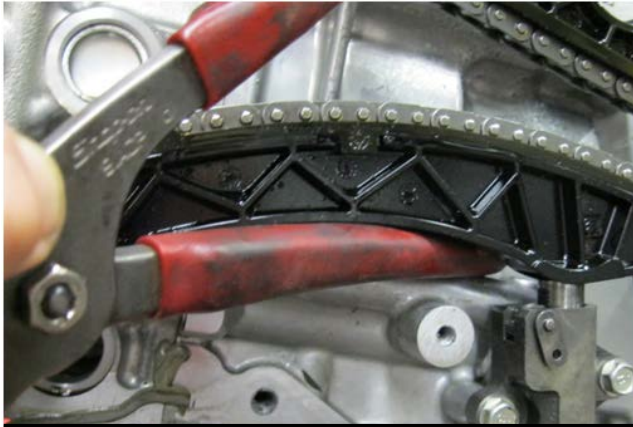
Rubber-coated plier handle inserted between a ledge area on the front of the block and the B1 lower chain guide VERY CAREFULLY lifting upward on the lower guide.

- Same as the left side, align the indicator links to the timing marks found on the cam sprocket assemblies. Install the chain guides and tensioner. Once proper positioning has been confirmed, pull the pin to release the tensioner. With your hand, grab and squeeze the upper and lower left side chain / guides together to allow the plunger in the tensioner to fully extend and click into its furthest notch as shown in the previous (right side) photo. **If necessary, insert a rubber-coated plier handle between the ledge area on the front of the block and the right side (B1) lower chain guide. Then, VERY CAREFULLY lift up on the guide just enough to get the extra “click” on the tensioner as shown in the photo below.**
